Manhole Inspection Summary

Manhole # S07MM1007MH

Insp Date: **5/4/07 11:23 AM**

Location Address: **ALLEY OF BEAUFORD AND 5002 ELMER**

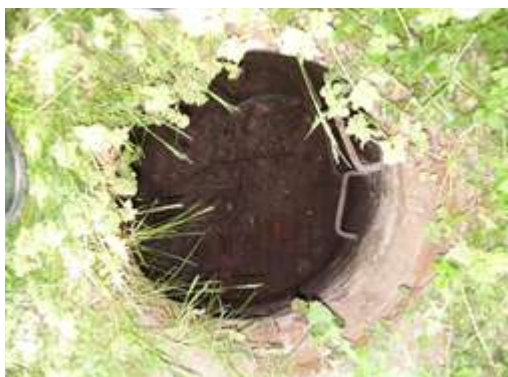
Top View

NOTE- SLIGHT DEBRIS

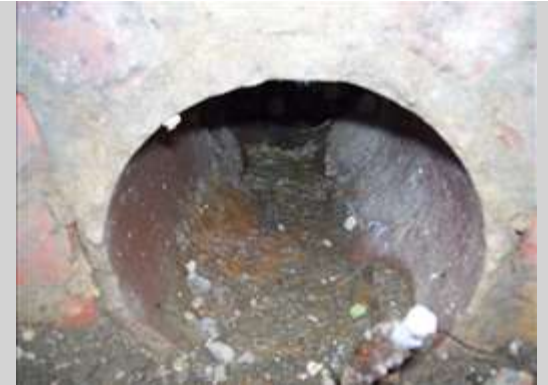
12 O'Clock Outflow

8 in. Circular Gravity Sewer
Pipe Out @ 12 O'Clock

NOTE- SLIGHT DEBRIS

Deposits: ☐ None ☐ Mud ☐ Sludge ☒ **Debris** ☐ Grease

Silt Depth: **0.25** (in.) Deposits Extent: **Light**
